DALTON ST. TURNTABLE

Demolition Profile

Costello Dismantling Co., Inc.

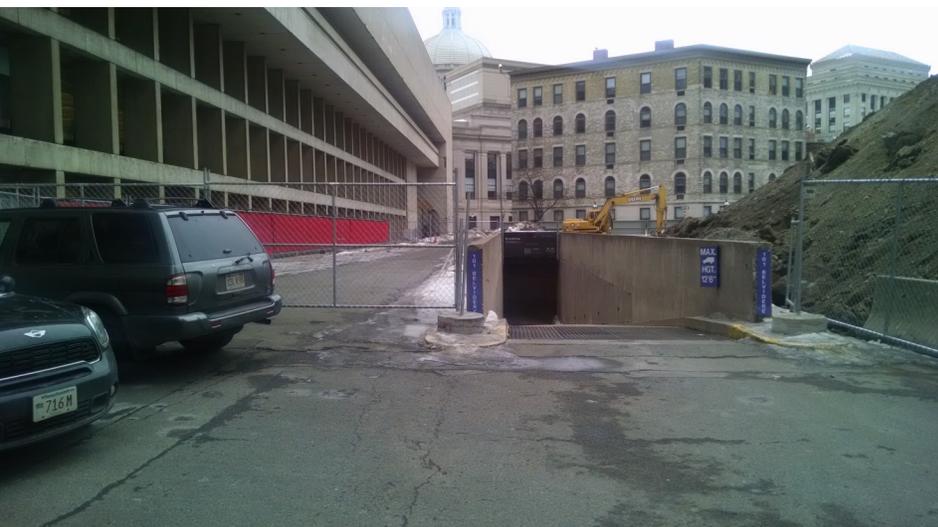
Entrance to the turntable, with Mother Church to the left and in the background

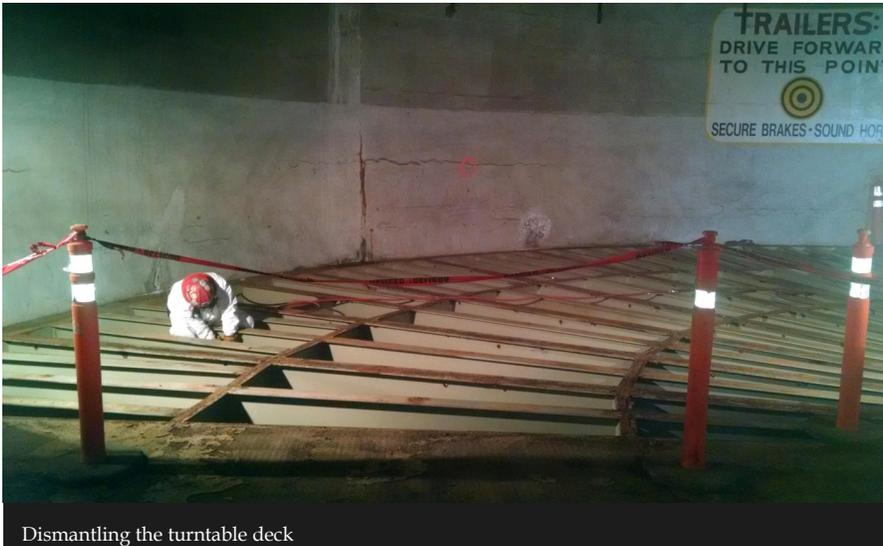
Dismantling the turntable deck

Our first challenge was to extract the steel turntable itself. The deck, framing and roller system were constructed of heavy structural steel, all coated with lead paint. Costello welders used supplied air and paid close attention to confined space protocol as they cut the turntable up into manageable sections and hauled them to the surface.

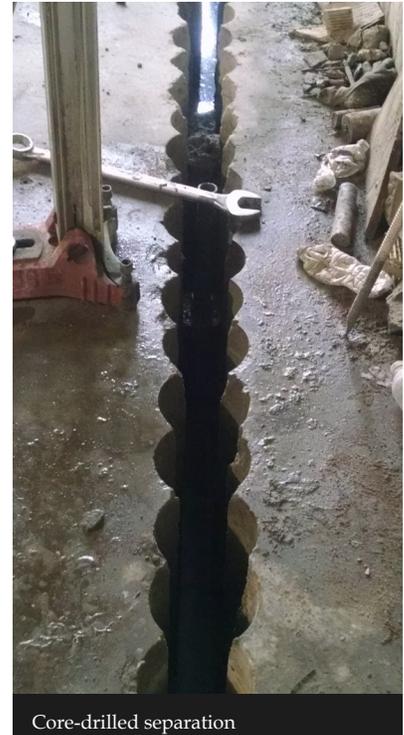
Core-drilled separation

While these actions were underway, the team developed an alternate method to structurally separate the thick turntable mat. Instead of using a track-mounted saw, we utilized overlapping 6" core drillings, performed at 5" on center, to perforate the perimeter of the mat, cutting cleanly through the massive slab. It was a laborious process - a single worker could only expect to complete 2 meters per day.

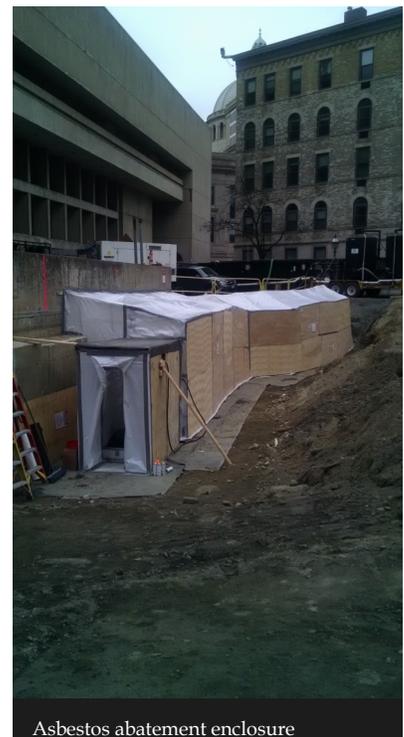
Asbestos abatement enclosure

Finally, an asbestos-containing mastic was discovered on the exterior of the ramp walls. The project was put on hold to re-group and develop new approaches.

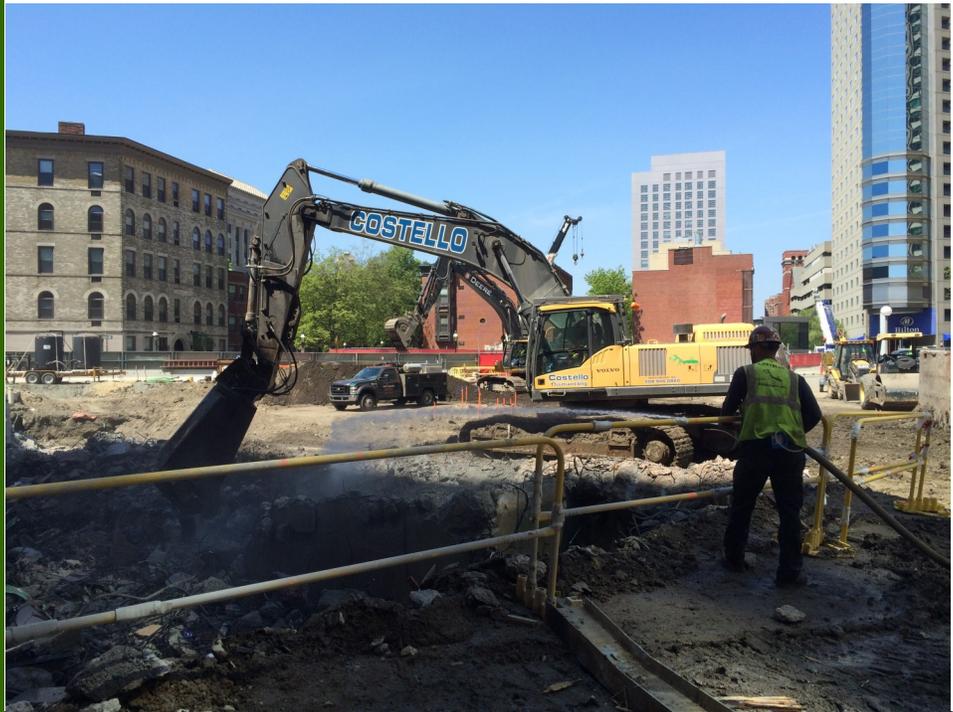
Managing dust during ramp demo

The entry ramp structure (and its roof) were likewise adjacent to the sensitive Mother Church, and needed to be separated prior to mechanical dismantling. The roof was shored up, painstakingly saw-cut (requiring multiple passes of a 72" saw), then carefully dismantled with a Volvo 480 equipped with a rotating shear. Working 20' at a time, this process took several weeks. The return trip on the ramp floor was quicker, requiring only saw cutting and hammering with a brand new 14,000 foot pound hammer.

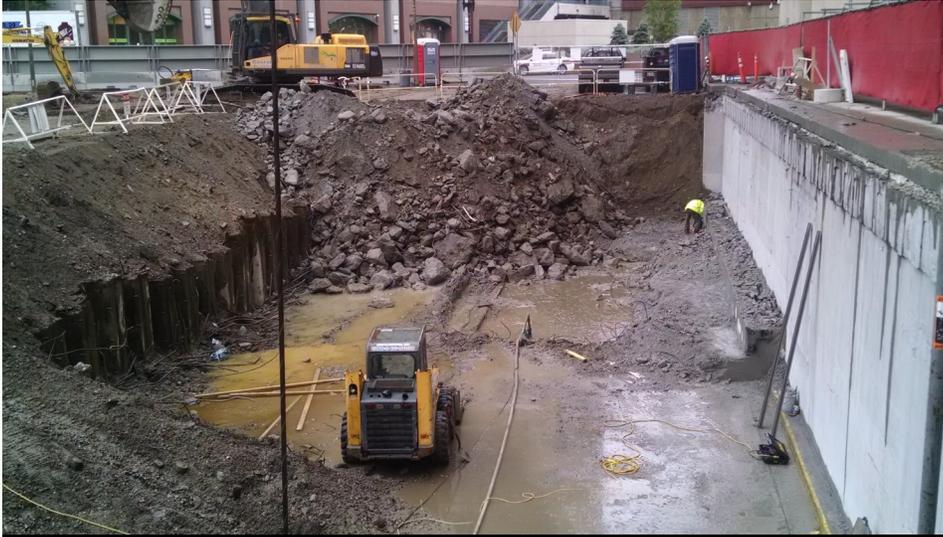
Final concrete removal
